**Shasta Lake Water Resources Investigation,
California**

Break-Point Analysis Office Report

**BREAK-POINT ANALYSIS SITE VISIT
MEMORANDUM**

SUBJECT: Shasta Lake Water Resources Investigation – Break-Point Analysis Site Visit

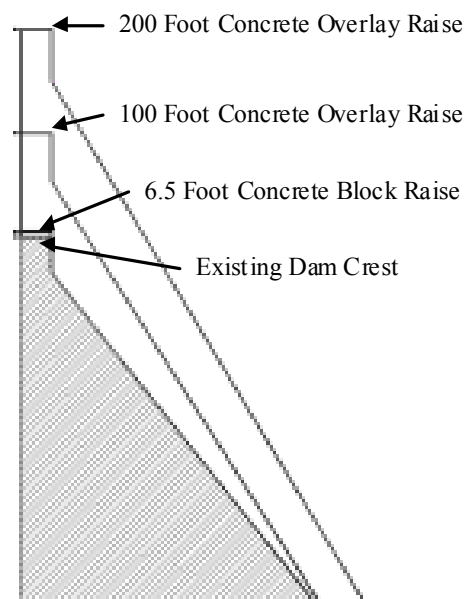
a. Main Dam Enlargement (Figure 1) – In Reclamation’s 1999 Appraisal Report (Appraisal Assessment of the Potential for Enlarging Shasta Dam and Reservoir), it was estimated that for a 6.5 foot raise the dam crest would be raised by additional concrete block lifts. For raises of 100 and 200 feet, the entire dam mass would be increased (crest and face). It was agreed during the site assessment, however, that for potential dam raises of a magnitude approximately equal to the width of the existing dam crest (30 feet), raising the existing dam crest in blocks could be considered feasible. For dam raises generally greater than about 50 feet, overlaying the existing dam with concrete mass and progressively enlarging the dam base should be considered.

Figure 1 – Cross section of Shasta Dam for Various Dam Raises.

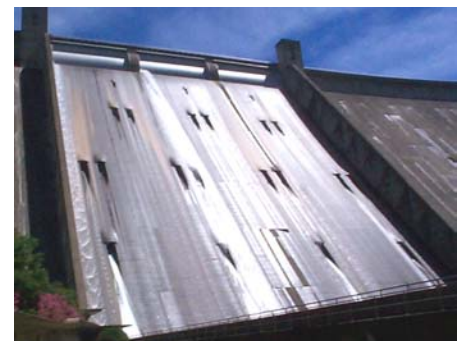
c. River Outlets (Photo 1) – Currently, Shasta Dam has 18 outlets in three tiers. There are four 102-

Photo 1 – Shasta Dam Spillway and Flood Control Outlets.

inch lower tier outlets (invert elevation 737.75 feet), eight 96-inch mid-level tier outlets (invert elevation 837.85 feet), and six 96-inch upper level tier outlets (invert elevation 937.75 feet). It was agreed that all the valves for the lower tier outlets would be replaced for any dam raise. It was also agreed that for dam raises above about 30 to 50 feet, the 8 middle tier valves would be replaced. The six upper tier outlets would be adequate for raises up to 100 feet.

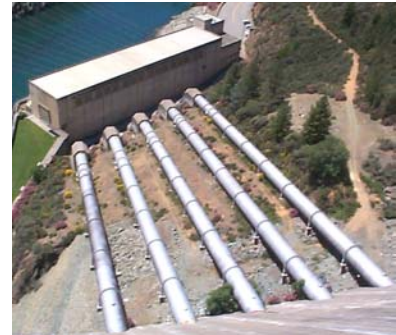
d. Penstocks (Photo 2) – There are 5 – 15 foot diameter steel penstocks running through the dam mass and to the downstream powerhouse. It was agreed that the exposed sections of the penstocks are adequate for dam raises to the maximum elevations considered. However, for dam raises above approximately 30 to 50 feet, the sections of the penstocks within the dam mass would need to be replaced. This is because of the potential for collapse due to excessive exterior pressures should the penstocks become de-watered.

Photo 2 – Power Penstocks and Powerhouse at Shasta Dam.

e. Powerhouse (Photos 2 and 3) – There are 5 main Francis-type turbines located in the powerhouse near the downstream toe of Shasta Dam. It was agreed that all the turbines would need to be replaced for dam raises above 100 feet and that the replacement would likely require construction of a new power plant. For essentially all dam raises lower than 100 feet, there would need to be some modification to the existing generating system but additional studies are required to identify the specific modifications needed. The modifications would depend on the extent of dam raise – head on the turbines and ancillary equipment.

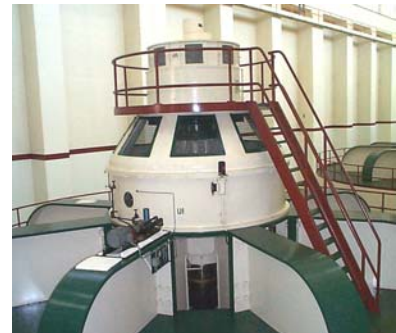
Photo 3 – One of 5 Main Generator in Shasta Powerhouse.

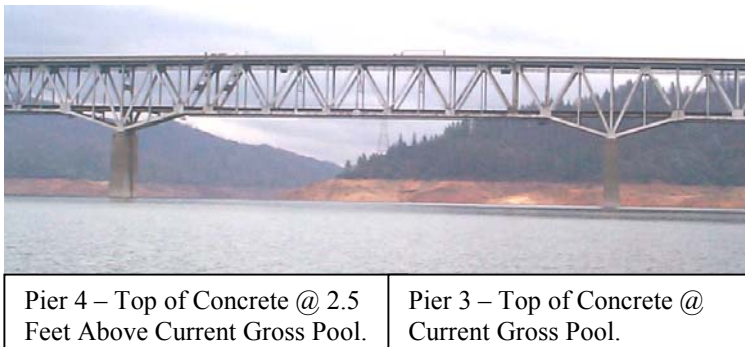
a. Pit River Bridge (Photos 4 and 5) – The Pit River Bridge includes two levels. The top level accommodates north-south vehicular traffic of I-5. The lower level accommodates UPRR traffic. The bridge was designed and is owned by the Bureau of Reclamation, however, Caltrans and UPRR are responsible for inspection and maintenance. Given the age of the mostly steel bridge (approximately 60 years), the

structure is in good condition. The tops of the concrete sections of the two center piers are near gross pool elevation with the top of Pier 3 at gross pool (elevation 1067). Any raise of the gross pool elevation of Shasta Lake would cause some periodic inundation to the lower portion of the bridge superstructure at Pier 3. With higher raises, more of the superstructure would be impacted as additional piers become overtopped beginning with Pier 4 (elevation 1069.5 feet). The lowest top of concrete elevation of the other higher piers (see Photo 5) is Pier 1 at 1088.58 feet.

Photo 4 – Pit River Bridge Looking East – 18 December 2002.

It was concluded that some periodic and infrequent inundation of a portion of the bridge superstructure would likely be feasible provided there were capabilities to adequately protect and maintain the structural bridge components. It was expressed that using protective coatings of the structural members even with aggressive maintenance would probably not be feasible due to the potential for induced damage. It was generally agreed that to insure the integrity of structural members that would be at or below a new gross pool elevation, they should not be subject to inundation. It is believed that even with infrequent inundation, protective measures would likely need to be some kind of enclosure of the structural members. However, this type of structural protection becomes infeasible for gross pool raises above the lower cords of the bridge (elevation 1091.5 at southern end of bridge). The UPRR stated in previous correspondence that a minimum clearance of 4 feet below the bridge low cord could be acceptable. This would translate into a maximum gross pool elevation of about 1087.5. A raise in gross pool to this elevation, about 20.5 feet, would be about 0.5 feet below the concrete lip of Abutment 2 at the south end of the bridge. With enclosure of the low bearings and trusses at Piers 3 and 4, a gross pool raise of 20.5 feet would not result in inundation (other than from wind and wave action at gross pool) of any structural members of the bridge.

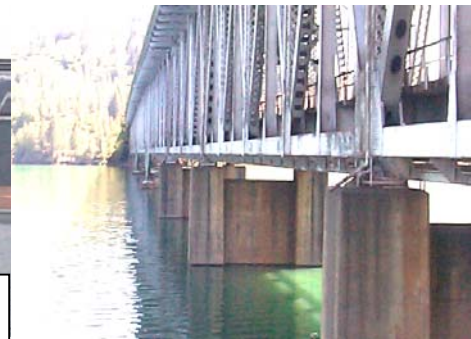
Photo 5 – Pit River Bridge Looking South – 20 May 2003.

The roadway and rail line of the Pit River Bridge have a positive slope to the north. The top of the concrete section of Piers 6 and 7, which are the two closest to the north abutment, are 1096.75 and 1098.47, respectively. Accordingly, the elevation difference between the maximum gross pool elevation of 1087.5 feet msl and the top of concrete at Piers 6 and 7 amounts to 9.25 and 10.97 feet, respectively. A raise in gross pool by about 20.5 feet, to maintain the UPRR minimum clearance (4 feet) at the south abutment, would leave a minimum clearance between the water surface at gross pool and bottom of bridge the low cord between Piers 6 and 7 of approximately 13.3 feet. This

would be sufficient for small watercraft but would limit some larger houseboats. Providing 20 feet of clearance for houseboats would reduce the allowable gross pool raise to about 13.8 feet. The U.S. Coast Guard has guidelines for navigational clearances, so they should be contacted and consulted with to ensure that the proper clearances are provided, since they may be different from what is being assumed is acceptable.

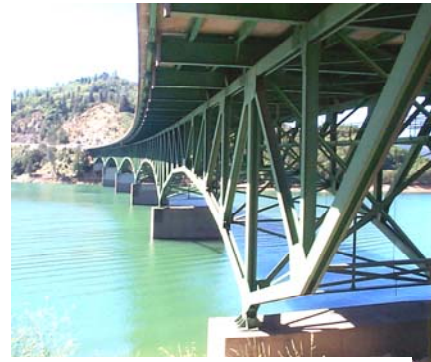
b. Antlers Bridge (Photo 6) – The Antlers Bridge, which supports a section of I-5, is located about 9 miles north of the Pit River Bridge. It is a steel structure and has a history of fatigue and safety issues. It was designed by Caltrans and it is considered a “fracture critical” bridge, which means that it is subject to partial or complete collapse if one of the “fracture critical” structural members should fail. Caltrans is in the process of preparing preliminary designs of a replacement structure with an alignment immediately east of the existing bridge. The replacement is in their long-range plans.

Photo 6 – Antlers Bridge
Looking South – 20 May
2003.

Any raise of the gross pool to Shasta Lake would begin to inundate portions of the Antlers superstructure and, given the condition of the bridge, would require full replacement. However, as the bridge is expected to be replaced within the planning and design periods of a modification to Shasta Dam and Reservoir, that replacement will be included in the without-project condition. Current preliminary designs by Caltrans are for the replacement bridge to be raised 6 to 8 feet above the existing bridge to allow for a potential dam raise of about 6.5 feet, and better match existing topography. Any plans for a raise higher than 6 to 8 feet in gross pool elevation of Shasta Lake need to be communicated with Caltrans engineers so that the bridge and roadway design provides adequate clearances.

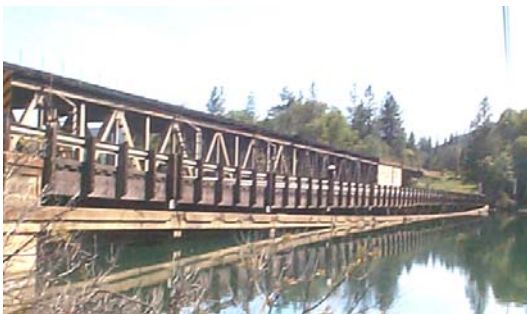
c. Doney and Charlie Creek Bridges (Photos 7 and 8) – These two bridges carry vehicular traffic. The current gross pool of Shasta Lake inundates the bridge piers and much of the superstructure for both the Doney and Charlie Creek bridges. It was agreed that with any raise of gross pool both bridges would be inundated and need to be replaced or abandoned.

Photo 7 – Doney Creek Bridge –
20 May 2003.

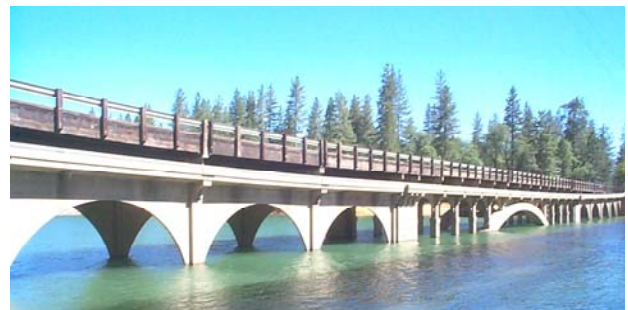
Photo 8 - Charlie Creek Bridge –
April 2002.

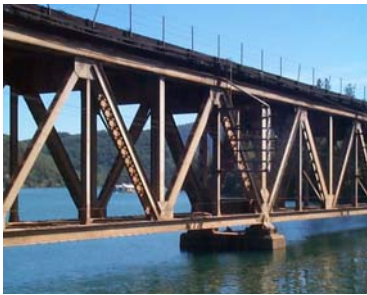
d. Doney and Sacramento River 2nd Crossing UPRR Bridges (Photos 9 and 10) – The current gross pool level of Shasta Lake is 3 inches below the top of concrete of the lowest pier (Pier 1) of the UPRR Doney Creek Bridge, and 10 inches above the top of concrete on the lowest pier (Pier 5) of the UPRR Sacramento River 2nd Crossing Bridge. It was agreed that with any increase in gross pool that both railroad bridges would need to be replaced.

Photo 9 – Doney Creek UPRR Bridge – 20 May 2003.

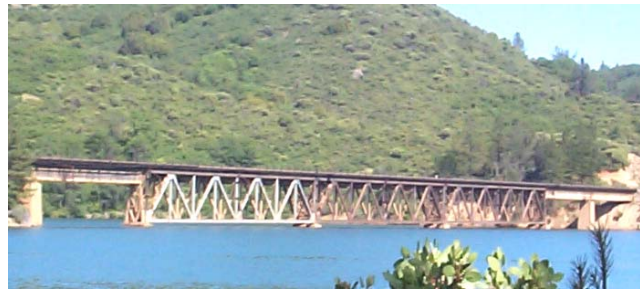
Photo 10 – UPRR Sacramento River 2nd Crossing – 20 May 2003.

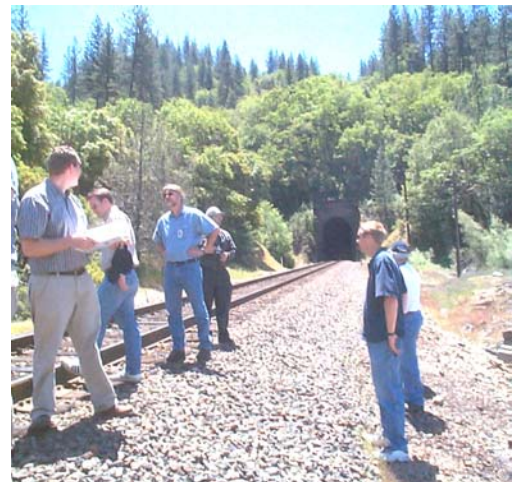
f. UPRR @ Bridge Bay (Photo 11) – There is approximately a 700-foot length of exposed UPRR track between two tunnels at the southern edge of the Bridge Bay Marina. The top of the ballast of the railroad is about 13 feet above the existing gross pool elevation at the southern end of the exposed track. There is a culvert under the track at this location to help drain a small area to the east of the track at this location. It was agreed that low level raises in gross pool over about 8 feet would require embankments on both the east and west side of the railroad at this location to protect the railroad. Sufficient area is available to construct embankments for gross pool raises up to 20 feet. As the Pit River Bridge and UPRR would be relocated for gross pool raises above 20 feet, this railroad segment would be assessed as part of the bridge replacement for higher raises.

Photo 11 – UPRR Track at Bridge Bay.

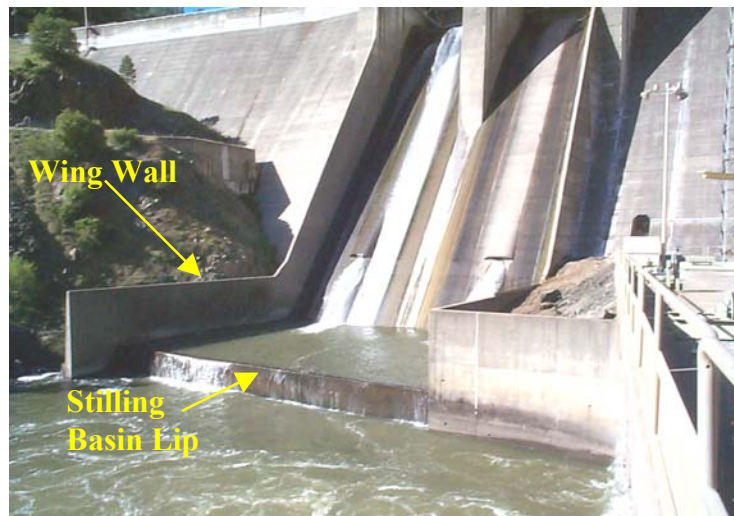
h. Pit 7 Dam (Photos 12 and 13) – Constructed in the mid 1960's, the Pit 7 Dam is a 200 foot high dam on the Pit River at the headwater of Shasta Lake. It is owned and operated for hydropower generation by the Pacific Gas and Electric Company (PG&E). The power plant for the dam includes two 56 MW turbines with maximum flows through the power plant of 7700 cfs. The power plant is on 4 levels with the top level exposed. The lower levels included the control room, turbines, and associated equipment.

The stilling basin lip elevation is at elevation 1075.5 feet (8.5 feet above existing gross pool of Shasta Lake). The elevation of the wing walls to the existing stilling basin is 1094.0 feet and the elevation of the powerplant yard is 1104.2 feet. The maximum raise in gross pool elevation before encroachment into the powerplant yard, excluding consideration of a PMF surcharge, would be about 37 feet.

Potential impacts of low level raises of the Shasta Lake gross pool would primarily include (1) reduced hydropower generation during periods of elevated water surface elevations, potential reductions in existing spillway capacities, and (3) added stresses to the side walls of the power plant.

Photo 12 – Pit 7 Dam Spillway and Stilling Basin – 21 May 2003

It was agreed that raising the gross pool elevation of Shasta Lake by up to about

20 feet could be accomplished without major modifications to the dam or appurtenances. Higher raises would likely result in the need for major relocations and modifications to the dam and hydroelectric facilities. Further studies to identify and assess potential impacts and remedial measures for low-level raises were recommended by the site visit team.

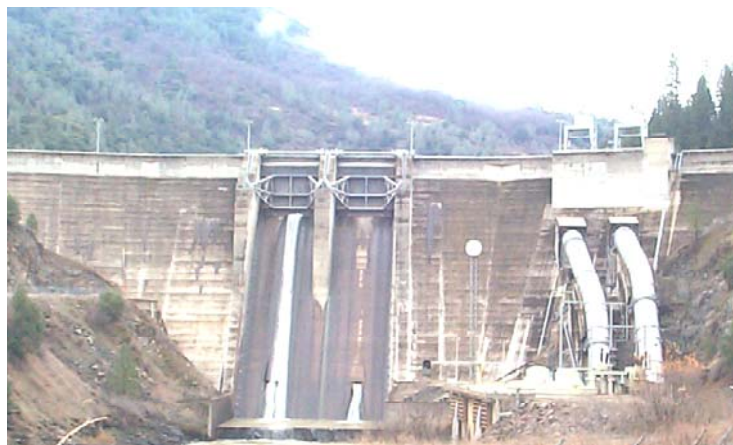
Photo 13 – Pit 7 Dam – December 2002.
